BIOS Update Instruction for the Vig731M Motherboard BIOS Version: E7A15IV1.1A5 and E7A15IV1.1A6

Identifying BIOS and ME Firmware

Step 1: Windows\WinPE BIOS and ME firmware Update

Step 2: Reprograming UUID

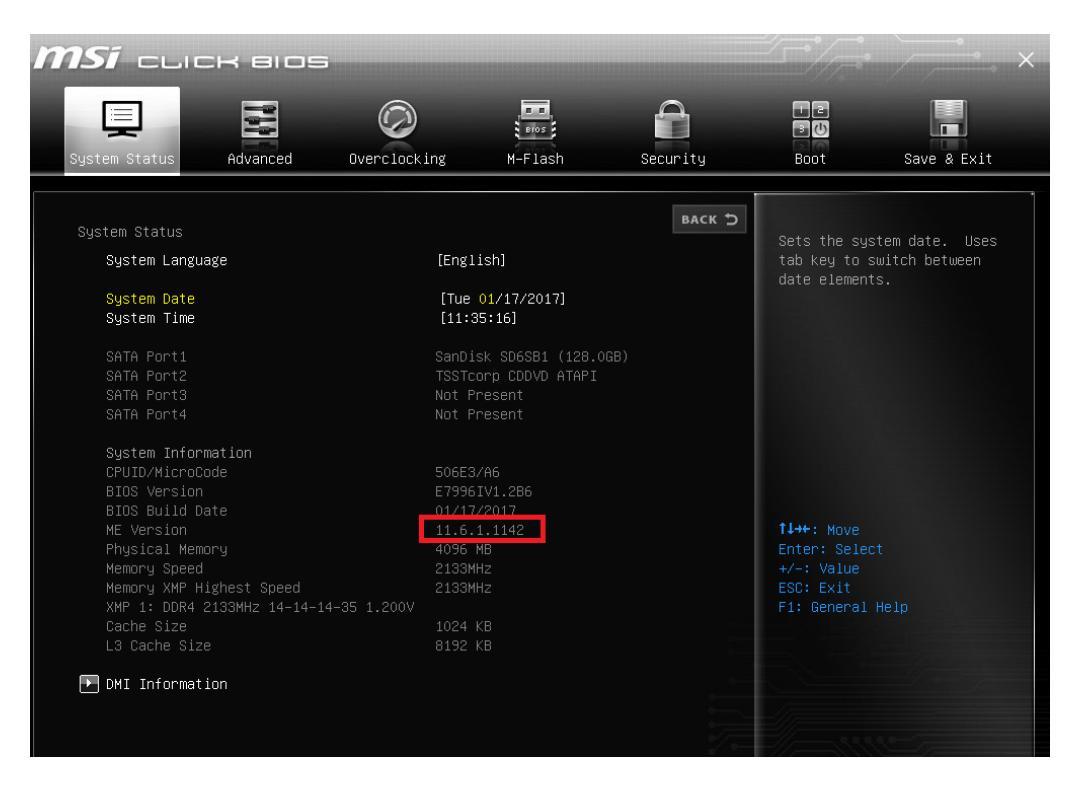
- 1. During boot, enter the BIOS setup by pressing Delete key.
- 2. Check the Main menu.
- 3. Under System information, ME firmware version is displayed.

Figure 1 – BIOS setup, ME firmware details
